Product: Cold rolled + White VX

Product: 1 x 304 + VX ext

Product: 3CR12 + White VX

Product: Cold rolled + elec plate + White VX

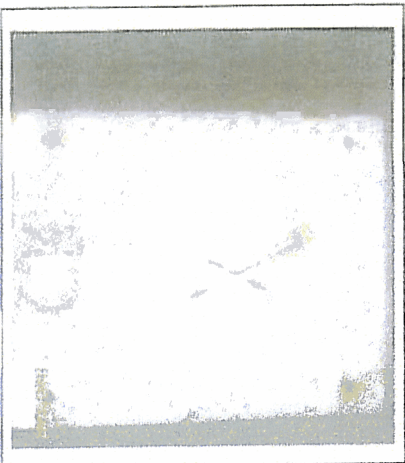
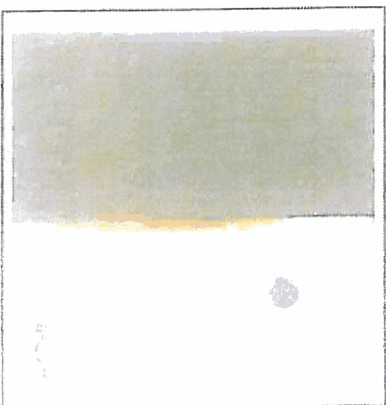
- 1) Panel was run in a salt spray cabinet according to SANS 7253.
- 2) Panel was inspected every 24 hours.
- 3) Panel was extracted from salt spray on 22/08/11 (504 hours).
- 4) Rust was evident on the edges and cross cut
- 5) Blistering was evident on the cross.
- 6) No delamination was evident on the edges or on the cross cut.
- 7) See photo below.

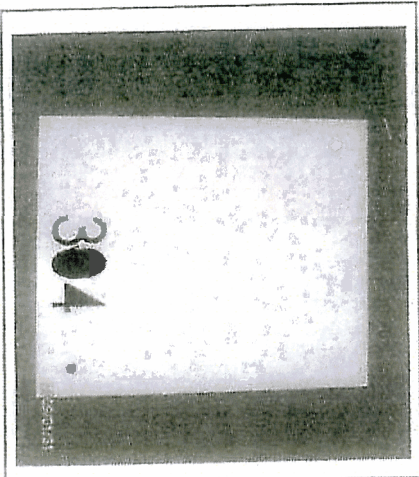
- 1) Panel was run in a salt spray cabinet according to SANS 7253.
- 2) Panel was inspected every 24 hours.
- 3) Panel was extracted from salt spray on 08/07/11 (642 hours).
- 4) No rust was evident on the edges.
- 5) No blistering was evident on the cross.
- 6) No de lamination was evident on both the edges and the cross cut
- 7) See photo below.

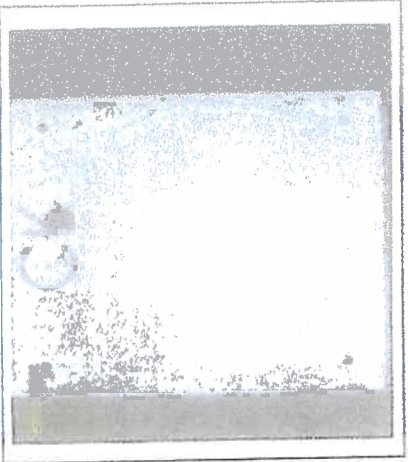
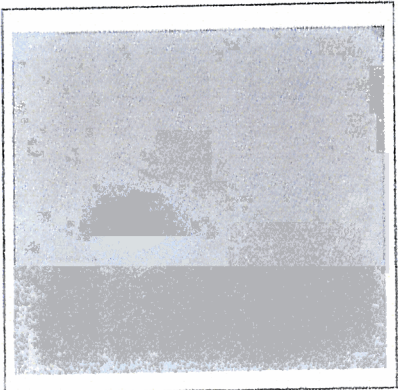
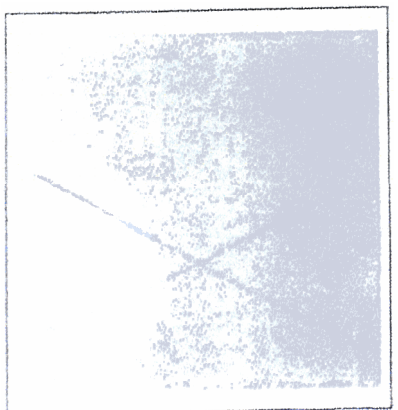
- 1) Panel was run in a salt spray cabinet according to SANS 7253.
- 2) Panel was inspected every 24 hours.
- 3) Panel was extracted from salt spray on 22/08/11 (504 hours).
- 4) Slight spot rust was evident on the cross cut
- 5) No blistering was evident on the cross.
- 6) No de lamination was evident on the edges or on the cross cut
- 7) See photo below.

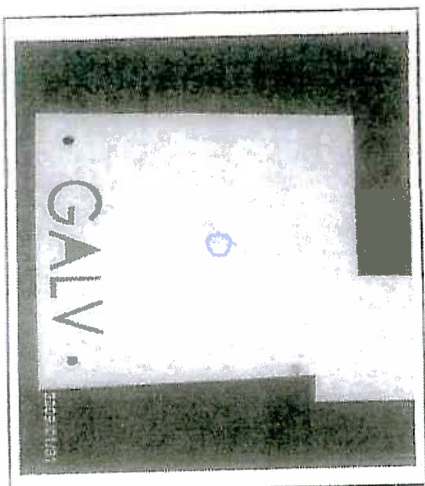
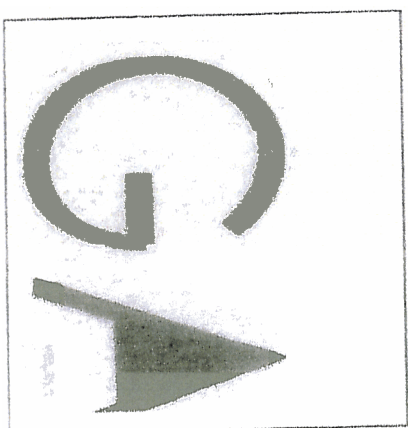
- 1) Panel was run in a salt spray cabinet according to SANS 7253.
- 2) Panel was inspected every 24 hours.
- 3) Panel was extracted from salt spray on 01/07/11 (500 hours).
- 4) Slight Brown Rust was evident on the edges.
- 5) Slight blistering was evident on the cross at 350 hrs
- 6) No de lamination was evident on both the edges and the cross cut.
- 7) See photo below.

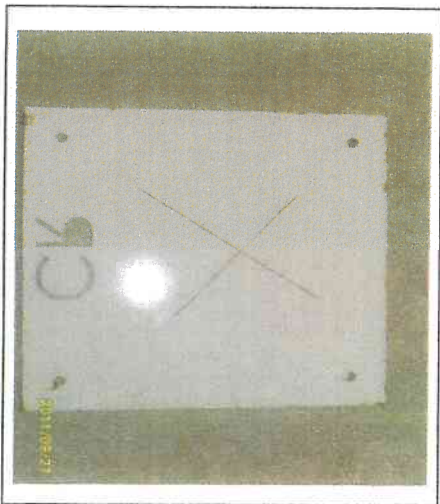
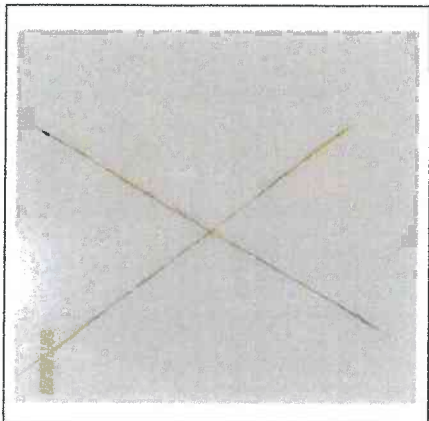
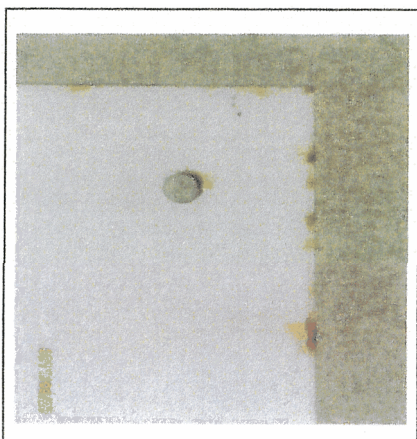
- 1) Panel was run in a salt spray cabinet according to SANS 7253.
- 2) Panel was inspected every 24 hours.
- 3) Panel was extracted from salt spray on 26/09/11 (516 hours).
- 4) Rust was evident on the cross cut and the edges, however no creepage occurred.
- 5) No Blistering was evident on the cross cut or edges.
- 6) No De lamination was evident on the cross cut or edges.
- 7) See photo below.
